CONDITION ASSESSMENT TECHNIQUES FOR WATER STORAGE TANKS

Sam Magill¹, David Barry²

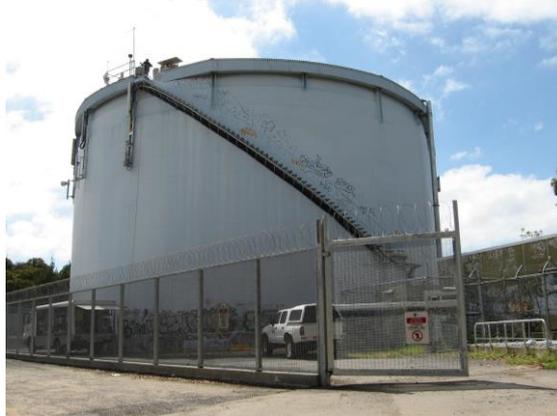
Compound

- The compound is not secure, and has no effective locking device.
- The fence has been damaged by a falling tree.
- There are holes in the netting where unauthorised personnel can enter the site.

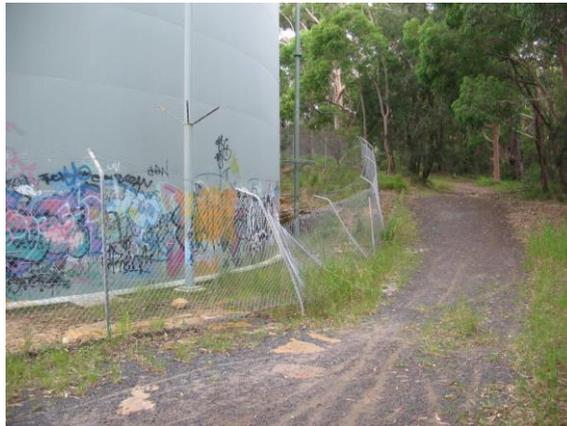
Vandalism

- The security fence has been damaged.
- There has been unauthorised entry to the tank site.
- There is offensive graffiti on the wall areas.
- The ventilation mesh has been damaged.

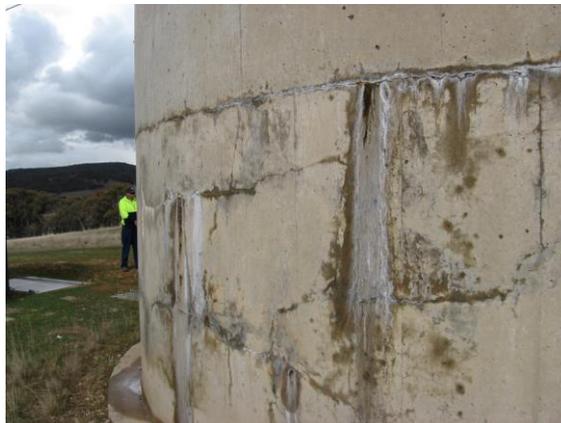
Walls

- There are leaks occurring due to cracking.
- There are leaks occurring due to poor construction.
- There is calcification present in the concrete.
- There is corrosion present around the sketch plate area.

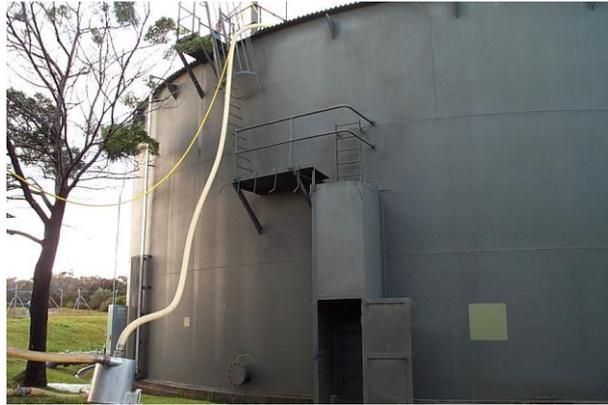
Ladder

- The ladder is unsafe to climb, structurally or design wise.
- The ladder enclosure area is not secure.
- The ladder can be accessed by unauthorised personnel.

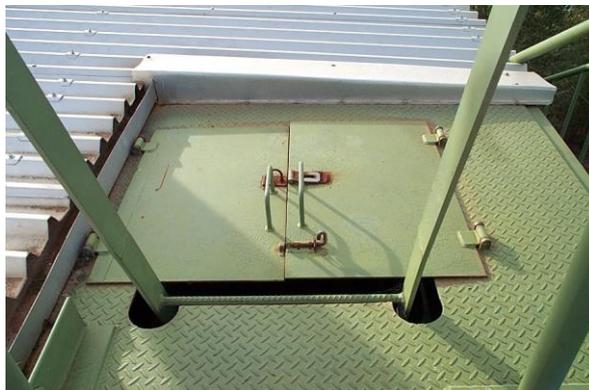
Entry Hatch

- The hatch cover is not sealed where the ladder styles extend through.
- The hatch cover has no front edge fitted.
- The hatch cover is not bird proof or secure against deliberate contamination being placed into the tank.

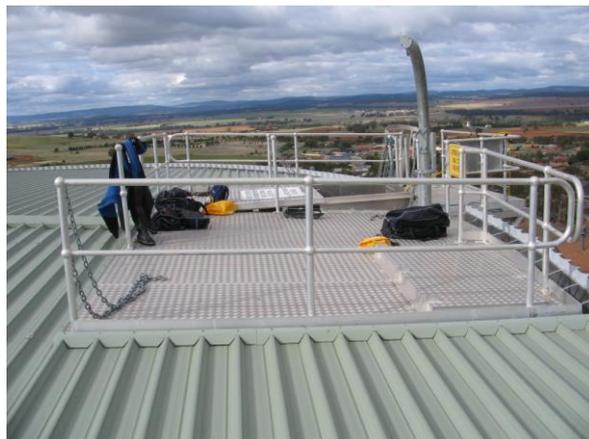
Platforms

- The platform has no safe working area present.
- The platform area is not sealed against natural or deliberate contamination.
- The platform area has no support for a rescue system.

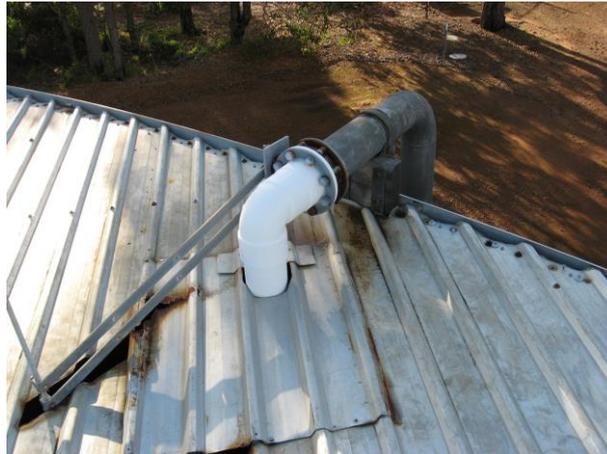
- The roof is unsealed where pipe work enters.
- The roof gutter is corroded through.
- The roof sheets are unprotected.
- Roof caps and flashings are missing.
- The roof sheet edges are not securely fixed.

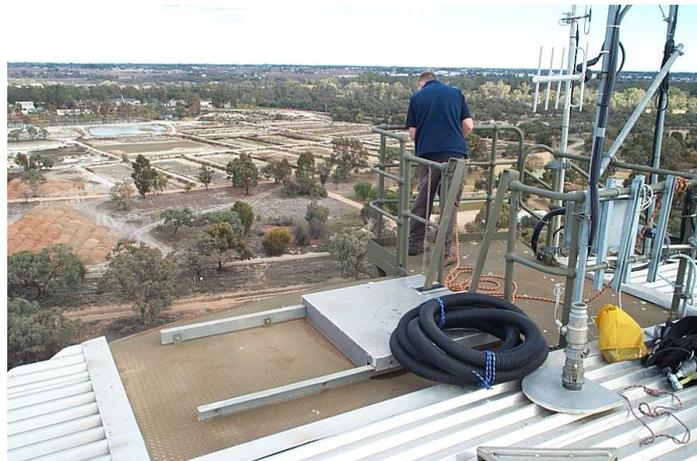
Handrails

- There are insufficient hand rails present.
- The hand rails are loose and poorly fitted.
- The hand rails are corroded and not safe to use.

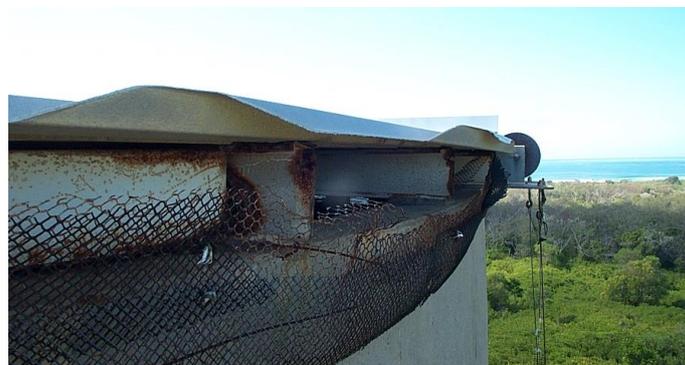
Ventilation

- The ventilation mesh is corroded.
- There are panels of ventilation mesh missing from under the roof area.
- The ventilation mesh has been damaged by vandals.
- The turbine roof vent has frozen and is not bird proof.
- The roof vent is not secured and may fall off the roof area.

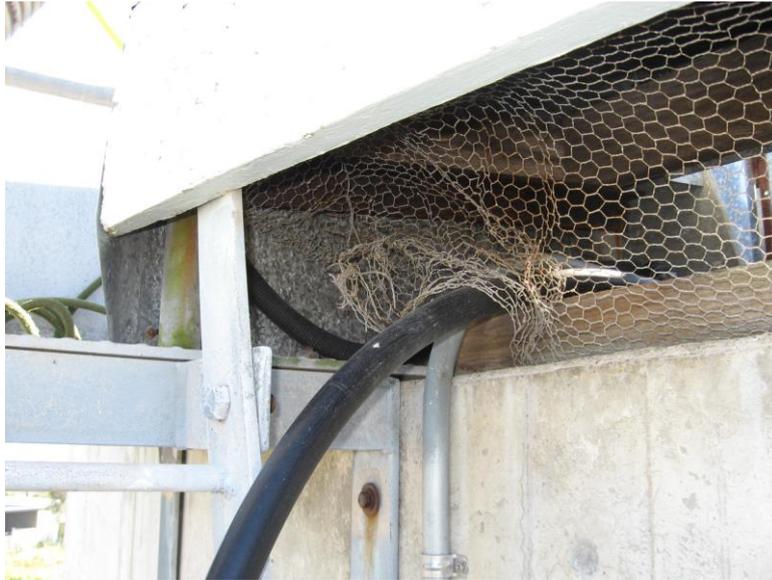
Bird Proofing

- Birds can enter past the defective ventilation mesh.
- Birds can enter the tank from under the level indicator pulley.
- The entry hatch is not bird proof.
- There are holes in the roof where birds are entering the tank.
