WHEN IS RESERVOIR CLEANING NOT JUST CLEANING?

- FOLLOWING THE EVIDENCE TRAIL

David Barry, *Director Aqualift Potable Diving Pty Ltd*
Jillian Busch, *Scientific Officer DBS Pty Ltd*

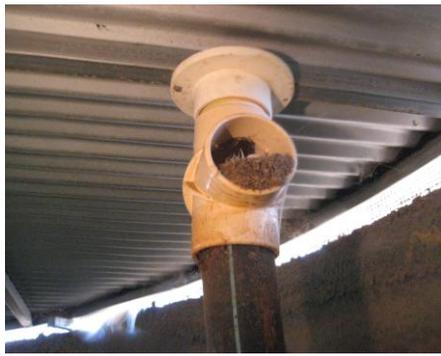
Figure 1 *Birds nest inside overflow pipe*

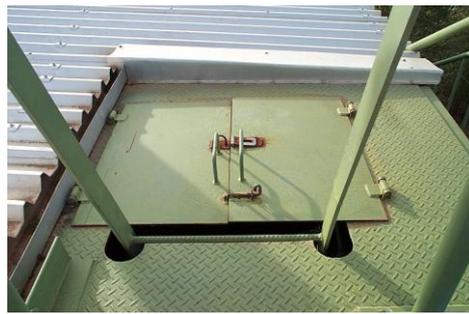
Figure 2 *Contamination exposure points*

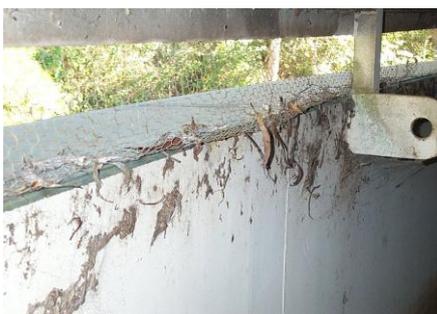
Figure 3 *Ventilation debris*

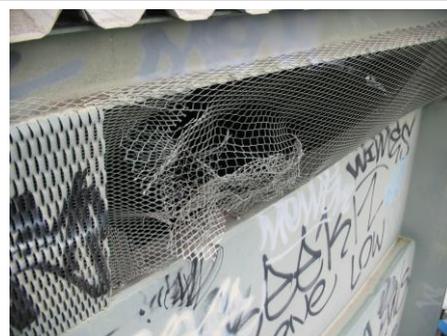
Figure 4 *Ventilation vandalised*

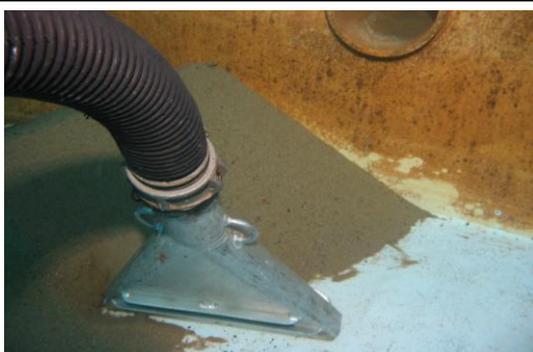
Figure 5 *Sand from Bore casing failure*

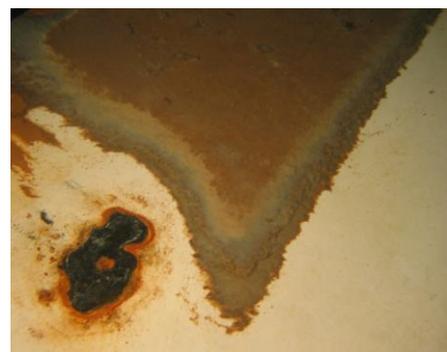
Figure 6 *Sediment profile*

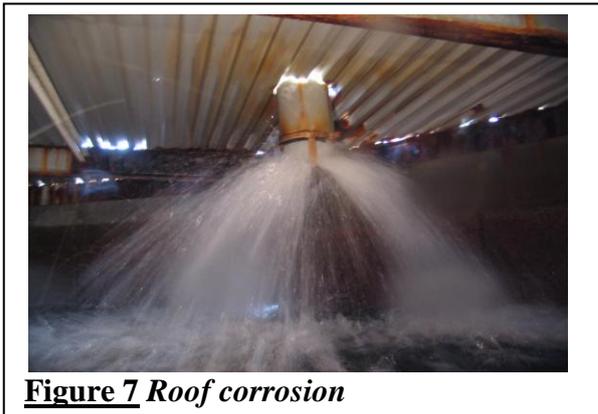
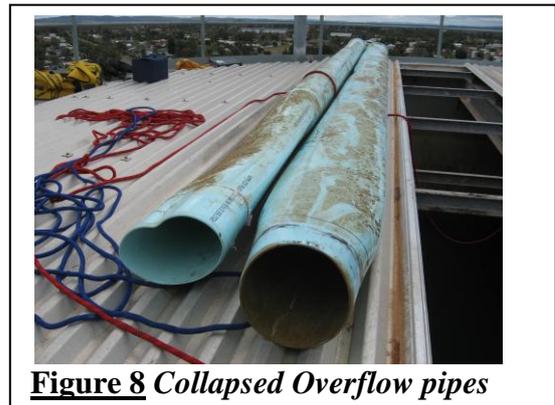
All too often, there is evidence of pipes wrongly connected. Scours set up as outlets allow sediments to be drawn into the reticulation system. Top fill inlets often disturb the floor sediments and spray adjacent roof framing - this can lead to corrosion of the roof structure as well as aerating the water that promotes chlorine decay. Inlets facing the wrong direction either towards the outlet, parallel to the floor, or creating too much circumferential water movement can all have a detrimental effect on water quality. Outlets positioned too close to the floor allow sediment entry into the reticulation system, while redundant or unnecessary pipe work within the tank creates sediment traps, reduces natural water circulation and adds unnecessary corrosion product to the water disinfection demands. A visual inspection can also determine whether the incorrect pipes are being used to operate the tank, whether valves have been opened or closed without operator knowledge (inlets used as outlets and vice versa), or whether the correct material has been used for an application such as an internal overflow pipe.

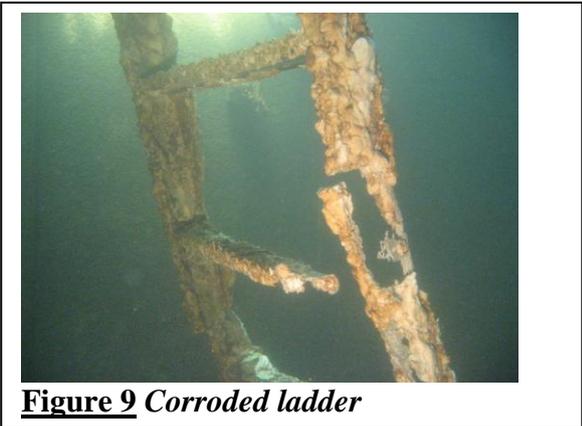
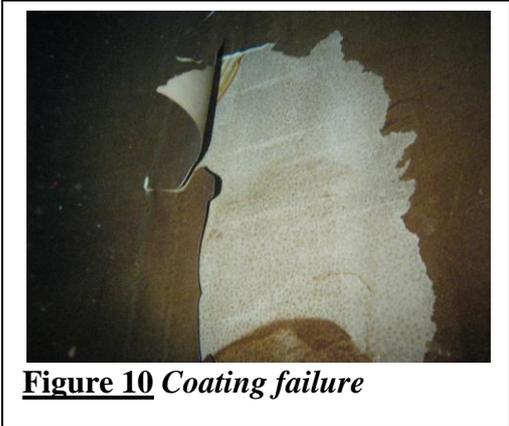
Areas that are more prone to coating breakdown include the floor, lower wall areas, support brackets, ladders, platforms and any galvanized materials within the storages. If these particular areas are in poor condition, water quality will be affected by contact with significant amounts of corrosion by-product. It is important to monitor coating performance and applicator ability (sometimes only obvious after years in service) to avoid repeating obvious problems in the future. A design life prediction of existing coatings based on time already run and deterioration noted to date can assist in budgeting both money and time for the next renovation project.

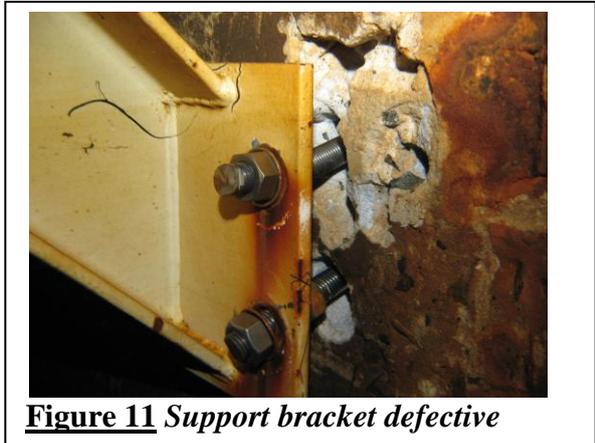
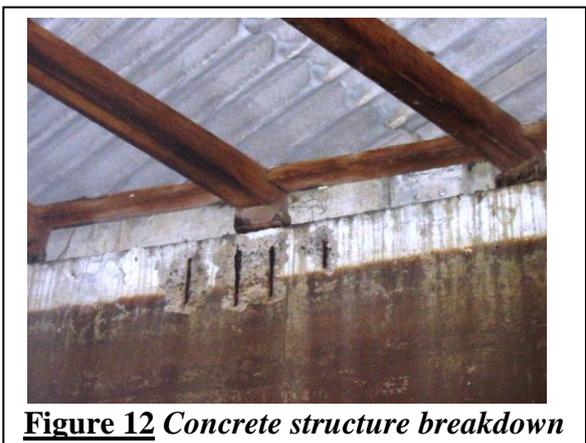
Upper wall deterioration can be identified by spalled concrete debris on the floor, caused by rafter connections or carbonation damage (a breakdown of concrete alkalinity). Rather than simply removing the debris, use it to identify where any problems may be occurring. Support posts can become weakened around the water line area by corrosion, causing roofing failures.

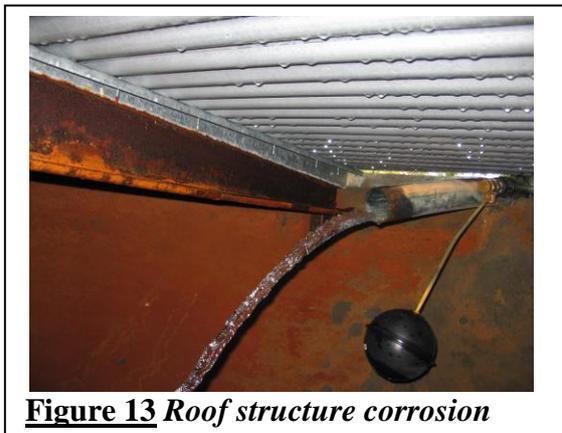
Roof framing deterioration can be noted from corrosion debris dropped onto the floor (from rafters, purlins or safety mesh). Some roof framing is not suitable for warm, moist conditions (rolled zincalume purlins with unprotected raw edges) and it is important to identify what materials work in this ‘under roof’ environment and which ones are failing.

Figure 13 *Roof structure corrosion*

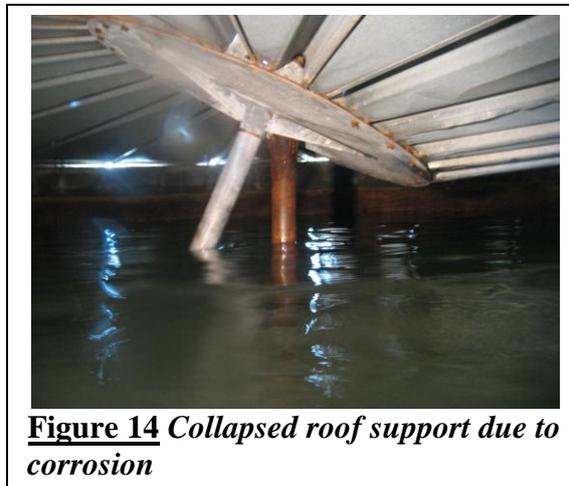
Figure 14 *Collapsed roof support due to corrosion*

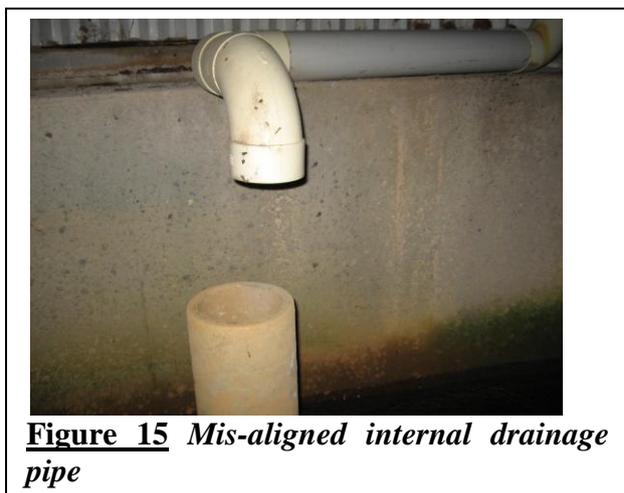
Roof gutter collection points can mis-align with the internal drainage pipes or overflow risers, allowing external water to infiltrate the storage whenever there is a rainfall event. Likewise, unsealed hatches, platforms and leaking or overloaded roof gutters all allow contamination to enter the storage. These areas are best checked in wet weather conditions or by simply using a ‘bucket of water splash test’. Infiltration areas can be observed within the tank by using an inflatable boat or by looking in and around the open hatch areas.

Figure 15 *Mis-aligned internal drainage pipe*

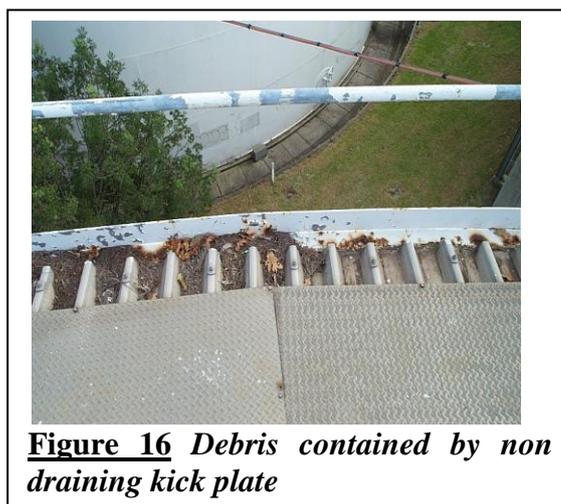
Figure 16 *Debris contained by non draining kick plate*

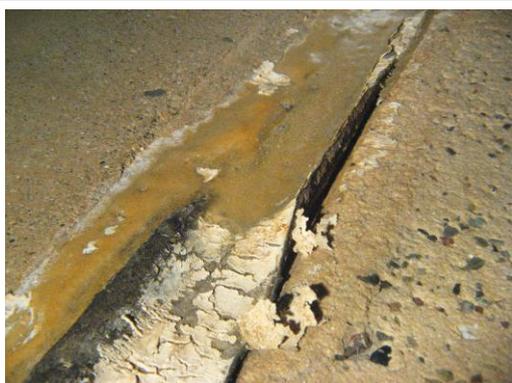
Figure 17 *Subsided floor seal*

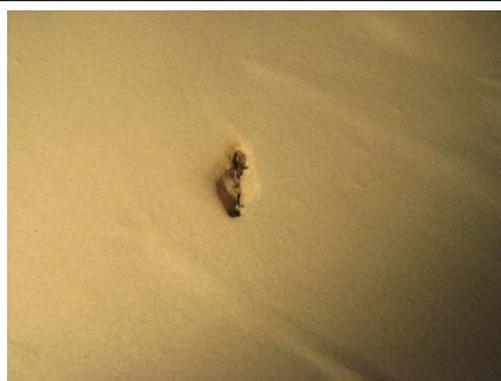
Figure 18 *Floor leak indicated by absence of sediment*
