## RESERVOIR RENOVATIONS: BEST CHANCE OR LOST CHANCE

Design and configuration of water storage reservoirs has in the past predominantly been focused on personnel safety, with very little consideration given to the quality of the water. As these reservoirs approach their half-life many require upgrades to their access, internal structures and pipe work. This paper will highlight five key areas where old designs have proved to be deficient and will offer solutions to improve the safety of both operating personnel and the stored water.

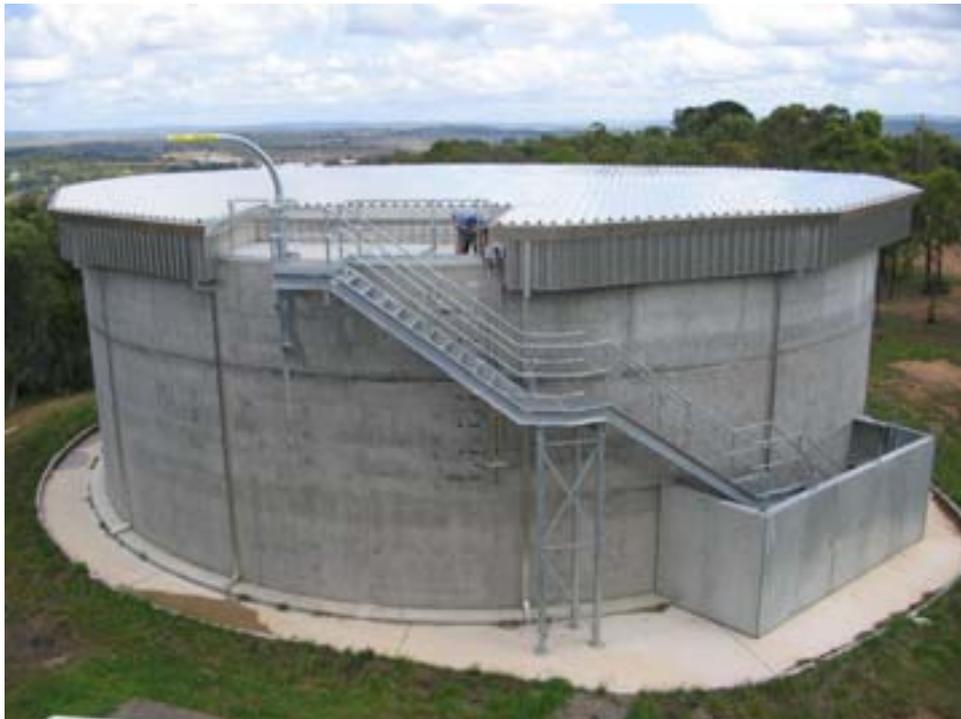
*Figure 1: An impressive external stairway but the entry hatch and platform areas remain unsealed.*

Design requirements at that time were focused almost solely on personnel safety. Access ladders, entry hatch areas, roof drainage and ventilation systems have consequently failed to deliver the safety requirements to the stored water that consumers are expecting and are entitled to.

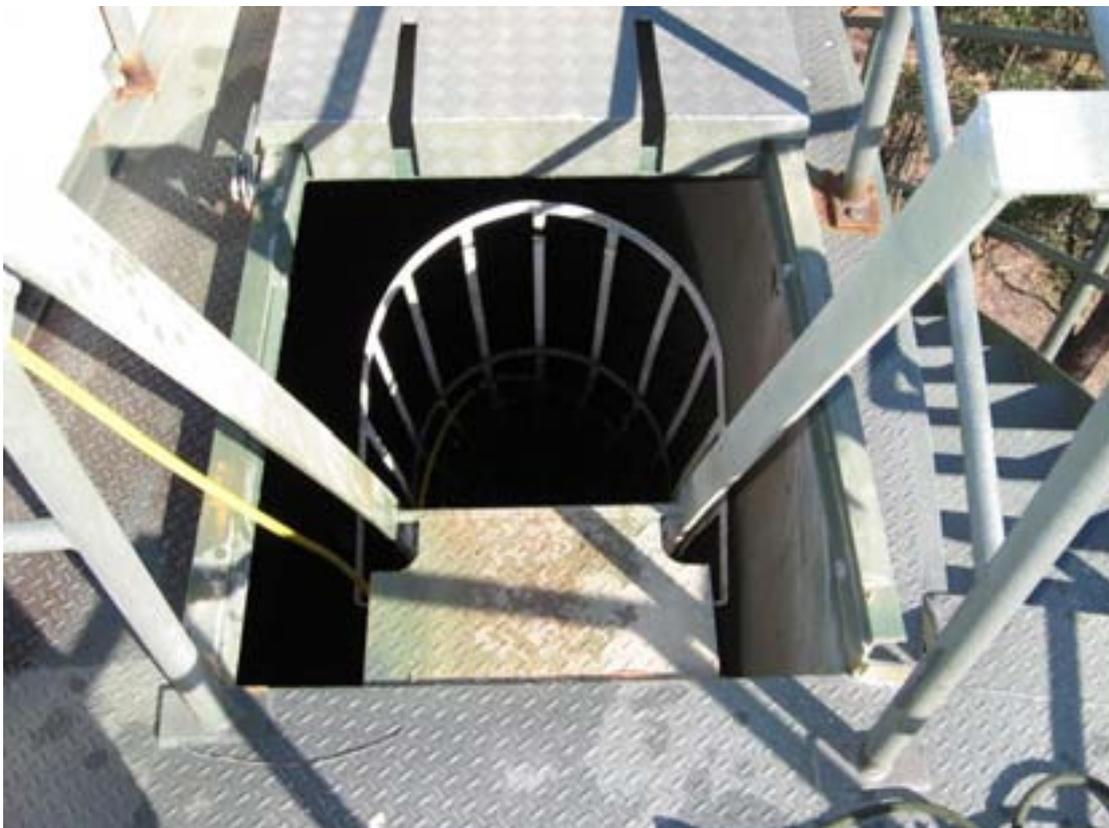
*Figure 2: Ladder stiles protruding from an unsealed entry hatch area.*

Until the mid 1990's, most tanks were emptied and drained for cleaning and inspection purposes. This entailed personnel climbing down into the tanks, often without the benefit of confined space knowledge or training. Ladder materials were also limited and galvanized steel was the preferred option, even though galvanizing had a limited protective life when immersed in water. Ladder and platform designs were based on the ability of personnel to climb them unassisted and rescue scenarios were often neglected or given low priorities. The AS 1657-1992 (fixed platforms, walkways, stairways and ladders) was used extensively, with little thought given to how it impacted on both confined space requirements (AS 2865- 2001 Safe Working in a Confined Space) or water quality. Consequently we have tanks fitted with sloping ladders and platform structures that prevent effective rescue from within the confined space environment. These same ladders generally have stiles protruding from out of the tank that makes it impossible to seal the entry hatch areas against natural or deliberate contamination.

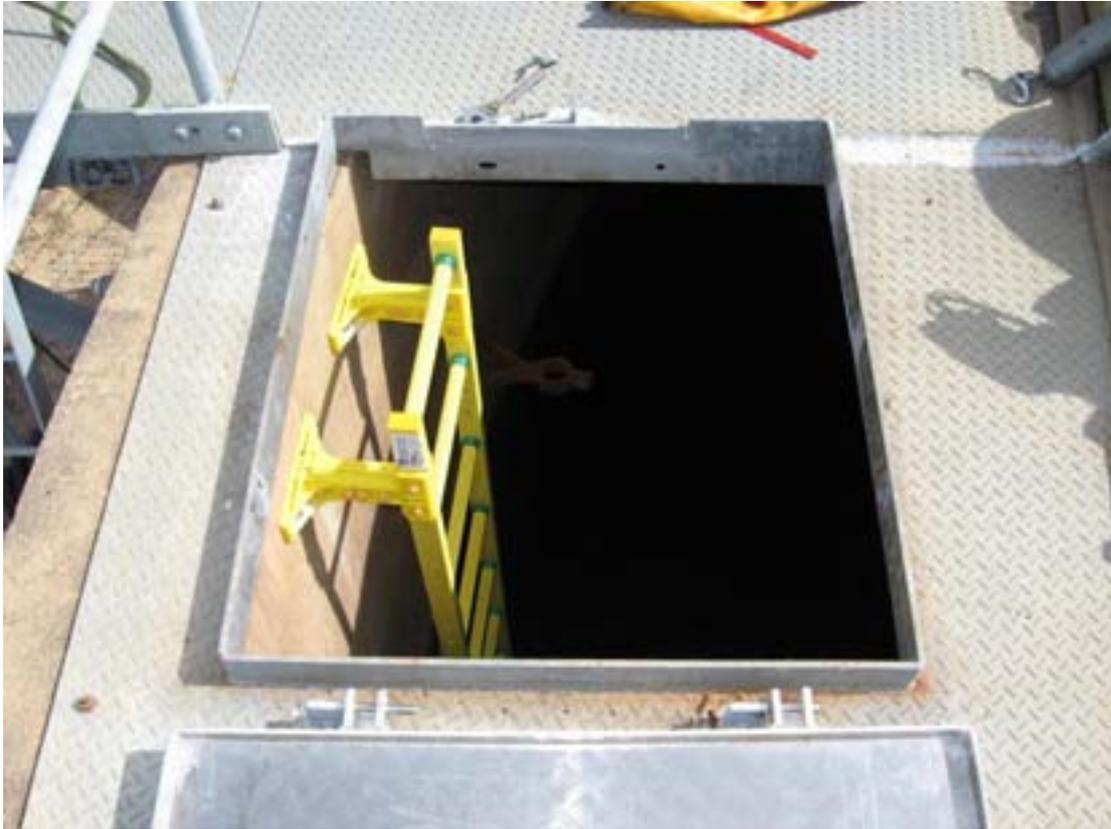
*Figure 3: The hatch frame sealed off and a new vertical ladder fitted.*

Use longer lasting, non polluting ladder materials such as FRP, and configure the designs to assist in a rescue scenario if required.

Vertical ladders are good for assisted climbing (using appropriate PPE) and they have benefits for rescue situations requiring several personnel at once to be lifted into or out of the tank.

But these ladders should not continue out through the entry hatch area – there are better methods of providing hand contact for the climber that do not jeopardise stored water quality.

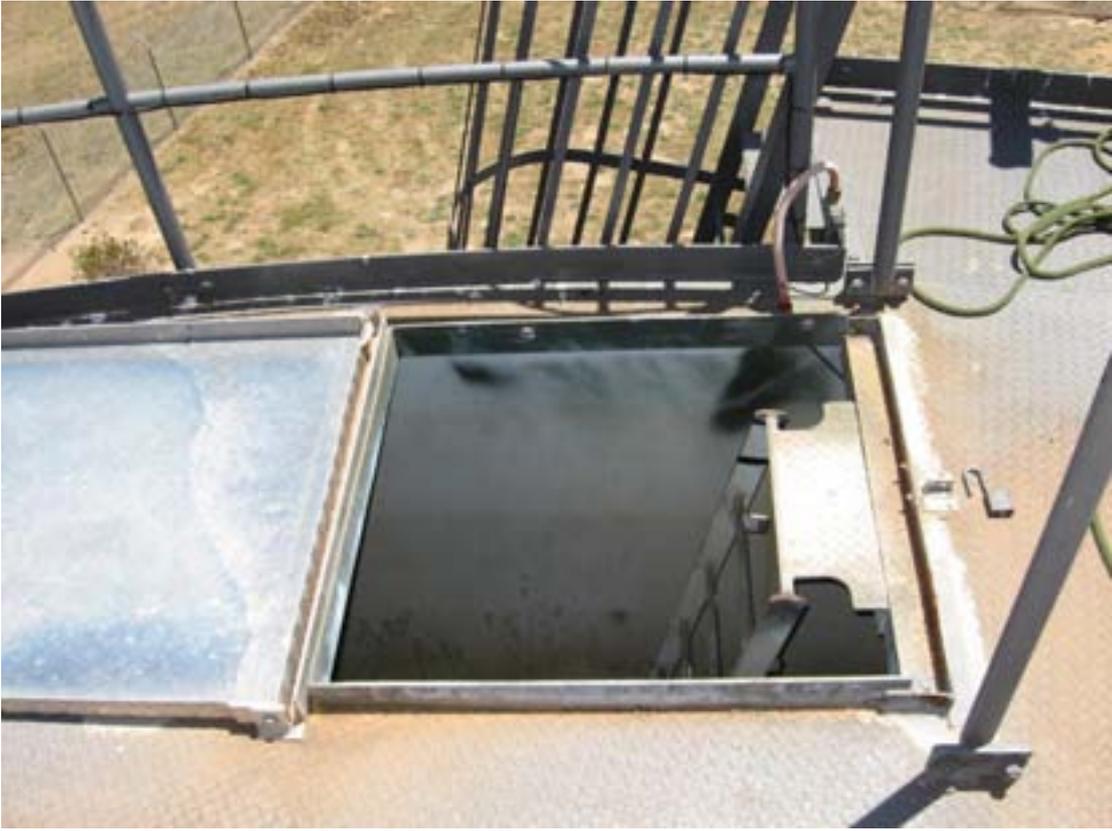
*Figure 4: The existing ladder stiles trimmed off, the front edge sealed and an overlapping cover fitted.*

Entry hatches need to be enlarged to at least 900mm by 900mm to allow easy access. The frame sealed onto the surrounding platform areas, the covers overlapped around the edges of the frame and having nothing protruding through them. Storm water and debris ponding needs to be eliminated from the immediate area to maintain a clean working environment when entering or exiting the tank.

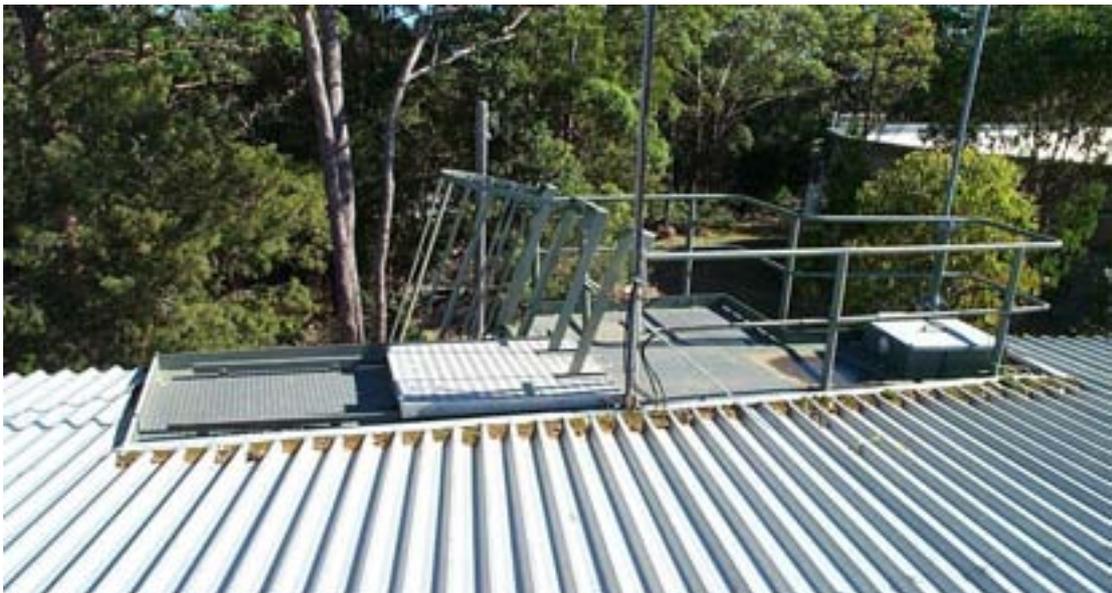
*Figure 5: Typical platform area – roof debris is ponding, unsealed hatch area and lack of effective guard rails.*

Platform areas need to be enlarged and sloped to encourage effective drainage, there needs to be adequate clearance to allow debris to be removed easily. Larger, uncluttered work areas assist in improving ergonomics and rescue systems need to be incorporated to assist confined space entry and exiting of the tank.

Guard rails need to be put in place to prevent personnel from falling off the immediate platform or roof area, but not to limit access to the safer areas of the roof, where regular maintenance needs to be carried out.

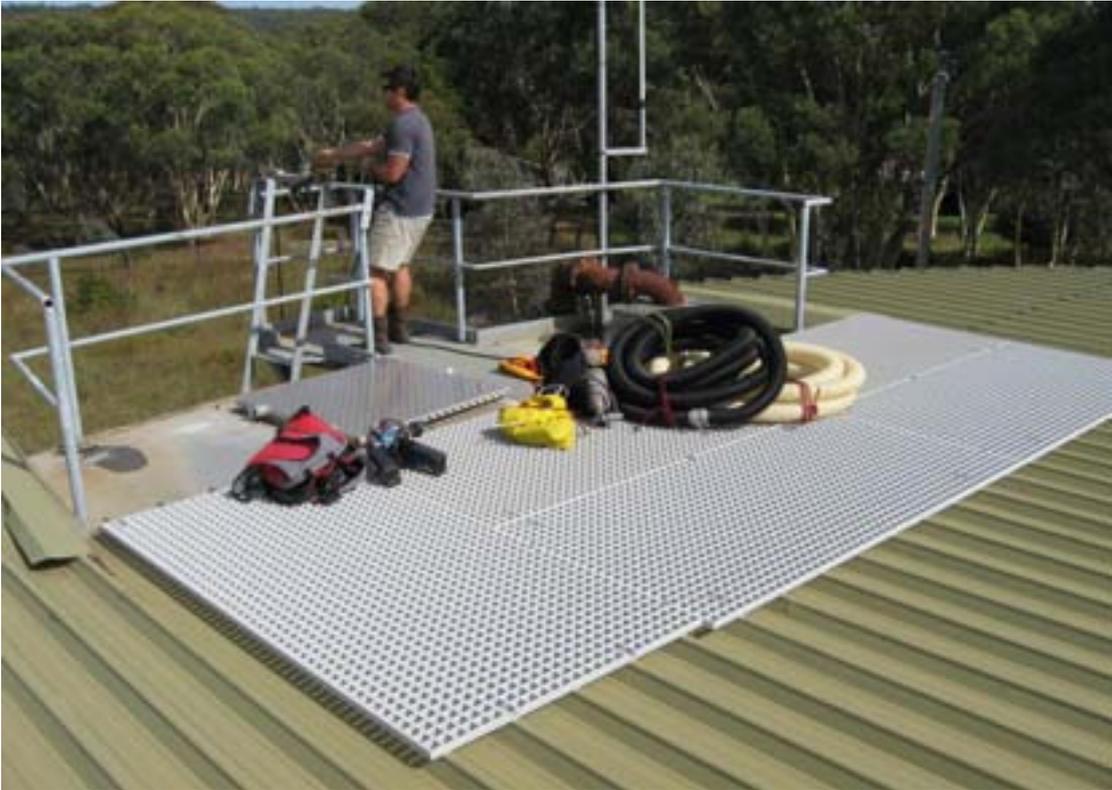
*Figure 6: An upgraded platform area including additional guard rails.*

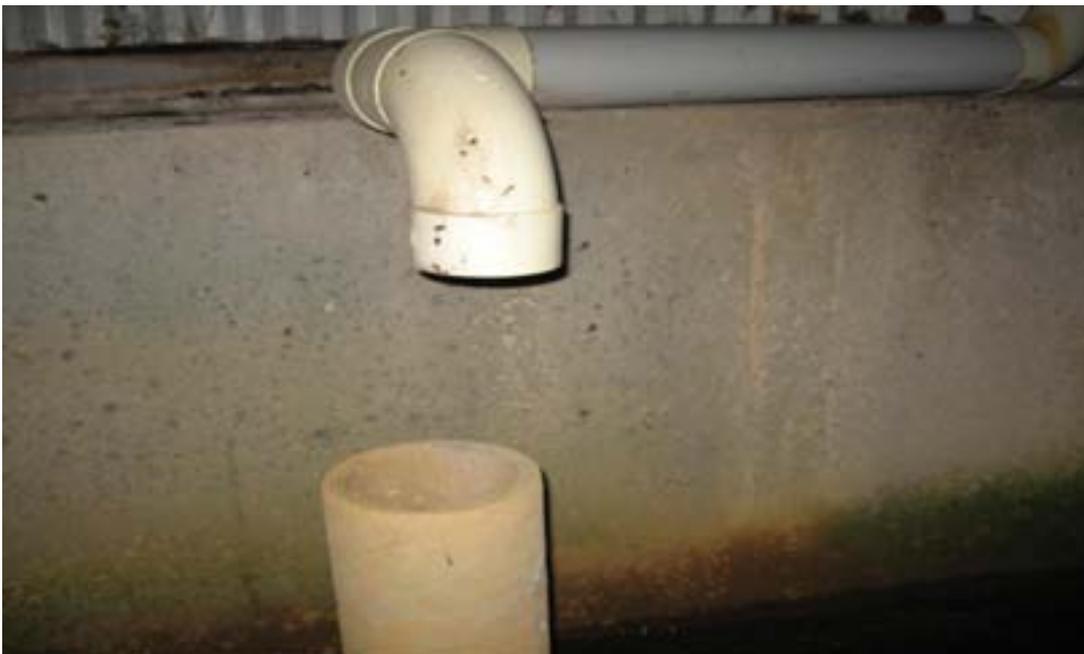
*Figure 7: A roof drain point not connected into the overflow.*

Change roof designs to avoid internal gutter systems, enlarge and re-align existing drainage points to cater for peak storm activity.

Install drainage points in ponded platform areas that exit out through the adjacent wall area and carry out regular monitoring during heavy rain periods to ensure contamination isn't occurring within the tank (an unpleasant and wet activity but necessary to avoid failures).

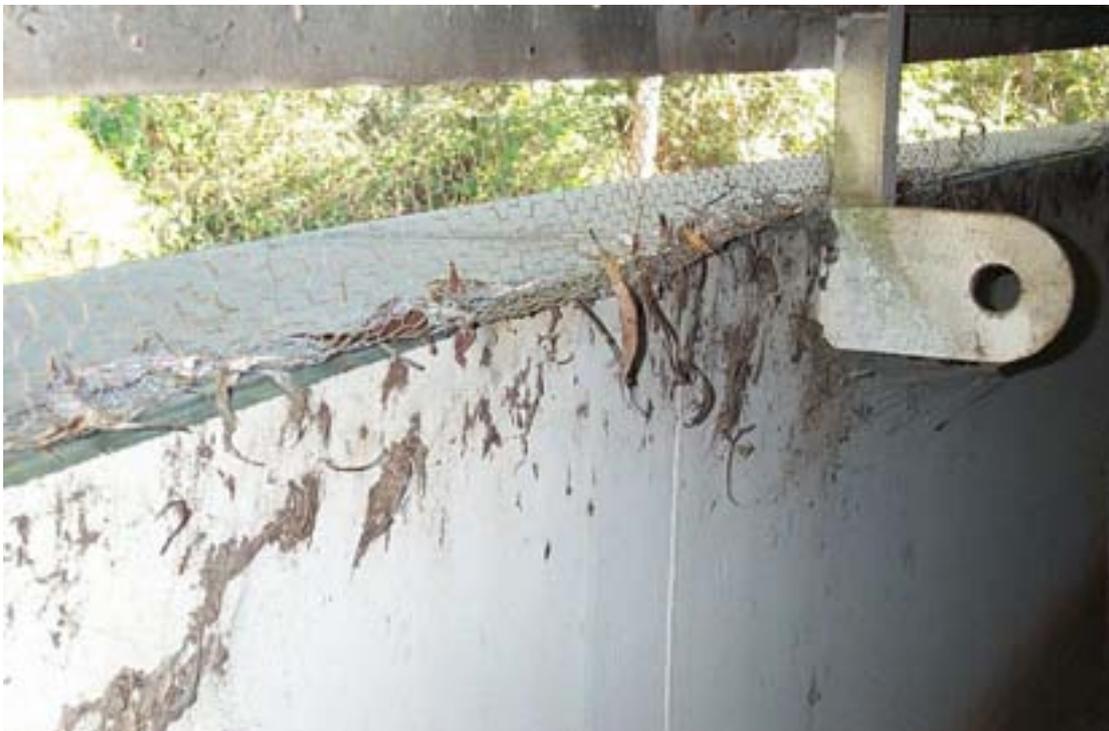
*Figure 8: Ventilation mesh not effective against leaf debris and wind born contamination.*

Design ventilation systems to suit the local environment. Windy areas should not have turbine vents fitted as these will wear out quickly through over use – fixed vents are preferred.

Mesh panels should be positioned away from prevailing wind areas to avoid excessive wind born contamination, the materials used should be corrosion proof and be fine enough to keep out insects and larger leaf type contamination.

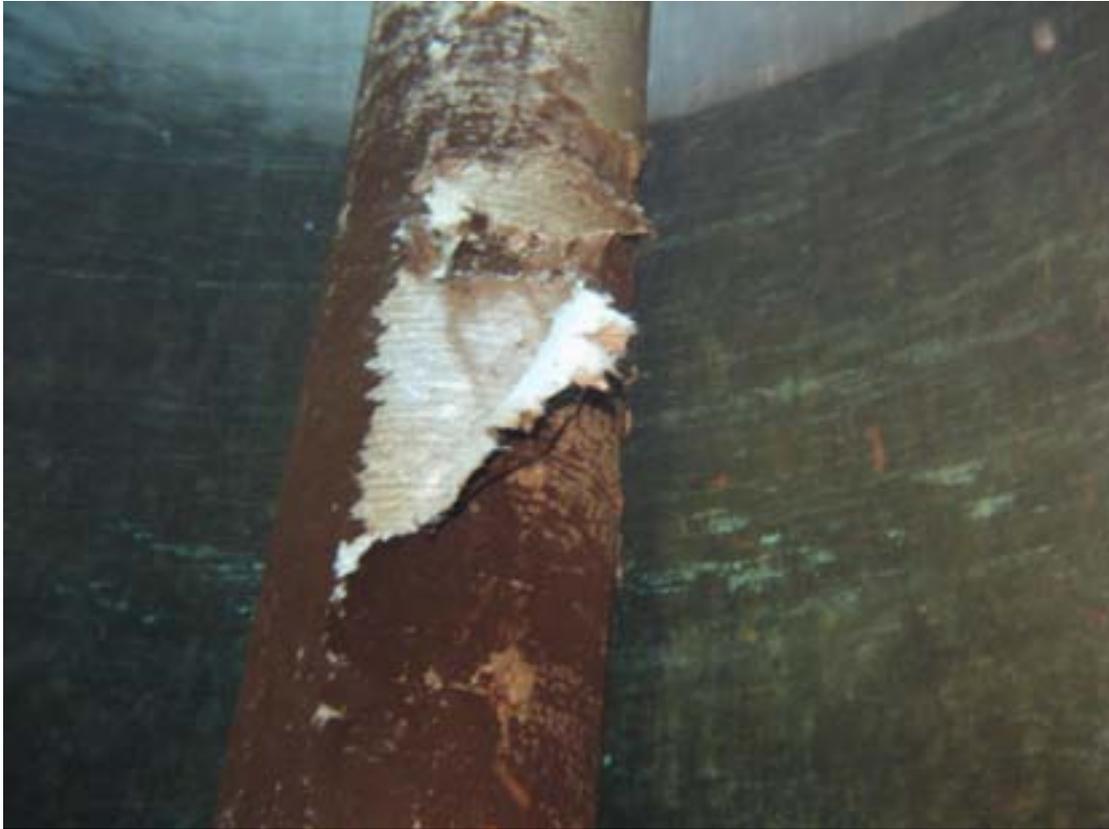
*Figure 9: An AC overflow riser pipe that is de-laminating.*

Removing or replacing any fitting that adversely affects water quality is important. Materials such as AC overflow risers, ductile iron pipes, galvanized metal items and any un-coated penetrations all need to be attended to during the renovation process. Fittings placed inside steel tanks are commonly coated with the same materials used on the wall and floor, but some items such as ladders and support brackets have been galvanized and these have deteriorated at a far quicker rate than the wall and floor areas.

Replace corroded or structurally deteriorated items with materials that are cathodically compatible and suitable for immersion.
